client The Fullerton Hotel industry Hotel & Retail location Shenton Way (Marina Boulevard), Singapore date 2010

PROBLEMS WITH EXISTING COATING

POLYGARD SOLUTION OFFERED

Polygard™ V-Deck 2000W | 2mm water-borne epoxy self-leveling system with broadcast finish

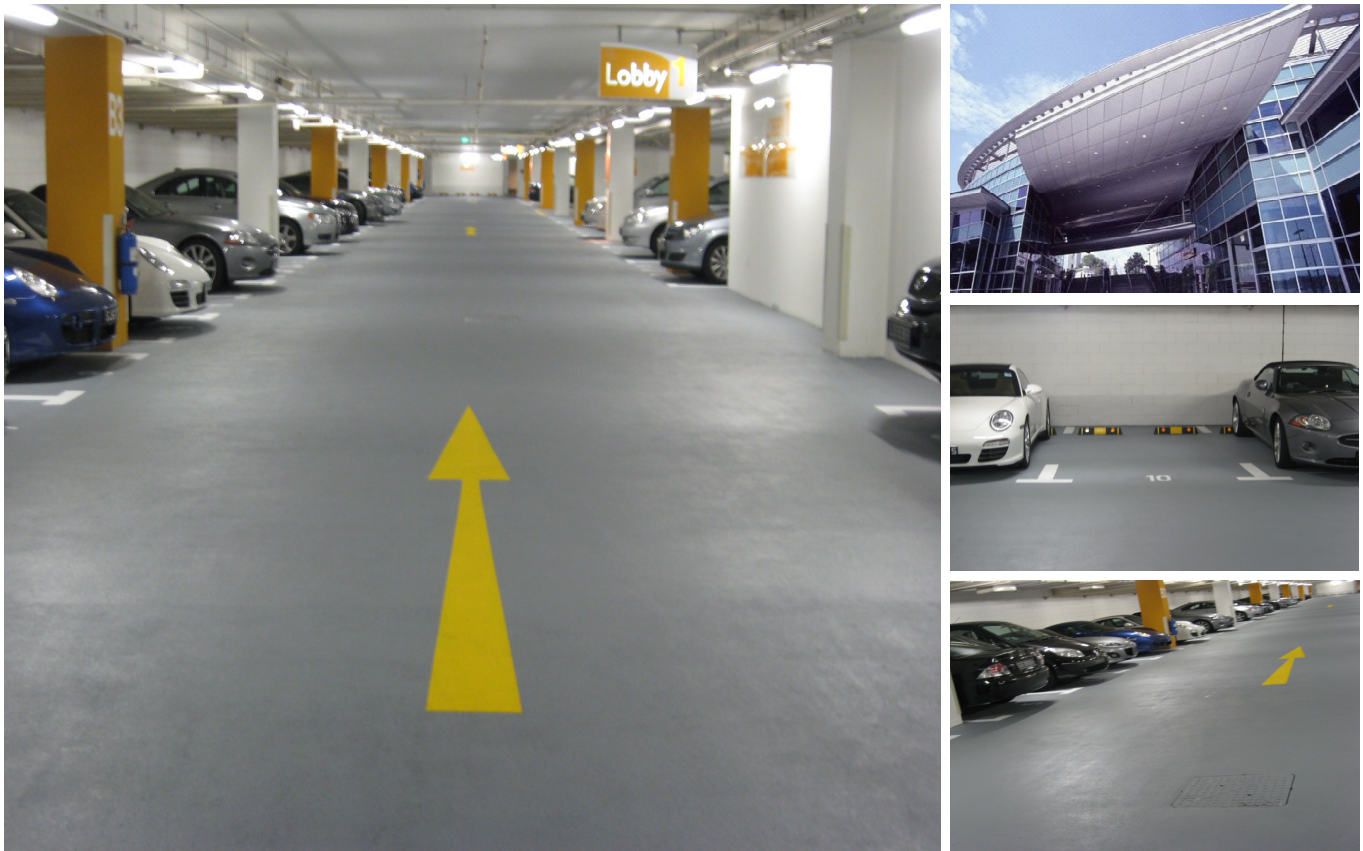
Due to the building's proximity to the sea and the failure of the basement tanking system, the existing coating that was installed only 2 years ago, blistered and subsequently delaminated from the concrete substrate. The cause of coating failure was attributed primarily, to blistering due to ingress of ground moisture and hydrostatic pressure. In addition, the wrong type of coating system was recommended and poorly installed by the previous coating contractor.

Polygard™ V-Deck 2000W, a water-borne breathable epoxy self-levelling broadcast system was recommended and successfully installed by Polymer International. This system was recommended because it allowed the ground moisture to permeate through the coating and not get trapped under the coating, thus preventing blistering.

For added slip resistance, silica sand and aluminium oxide grits were incorporated onto the coating system.

To date, the coating is still intact and will continue to provide the customer with many years of continued service in the future.
