client SPH industry Printing & Packaging location Jurong, Singapore date 1999 - 2008

**TOTAL INSALLATION AREA**

25,000 m<sup>2</sup>

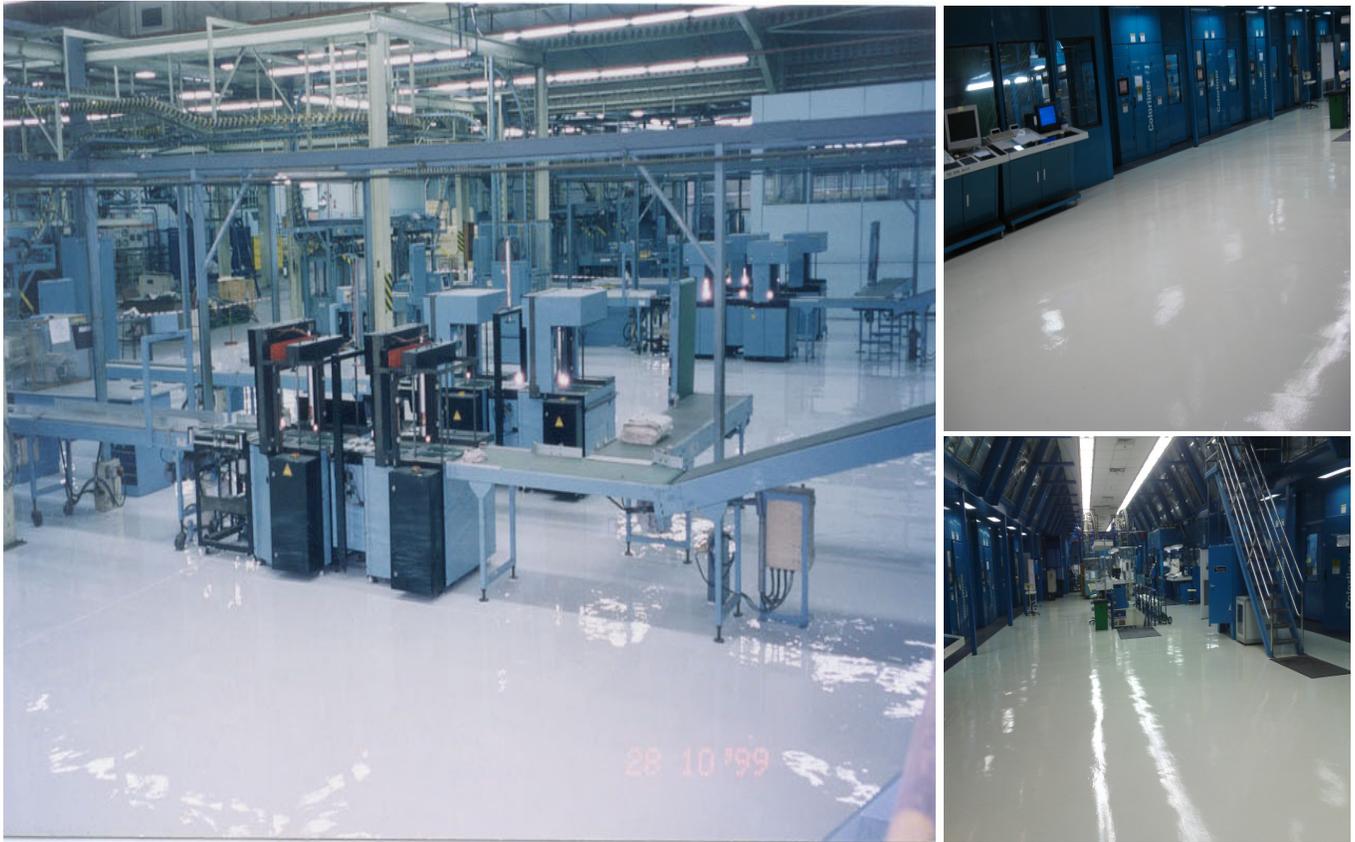
**Polygard™ SLT 1090** | 1mm thick solventless epoxy self-leveling system with smooth finish (PU topping)

In 1999, SLT 1090 was applied on the Mail RM / Reel Preparation area. Three years later, the system was also applied onto the new extension. To date, 11 years after installation, the floor is still in good condition and continues to provide protection and meet customer's expectations.

Over the years, the existing concrete in the production areas weakened due to daily mechanical and impact abrasion by forklift movement and heavy machineries, which led to the affected area being dusty as the surface of the concrete loosens.
